## Availability and Risk Assessment of 380 kV Cable Systems in Transmission Grids

<b>S. MEIJER, J.P.W. DE JONG</b>	<b>J.J. SMIT, B.W. TUINEMA</b>	<b>H. LUGSCHITZ</b>	<b>G. SVEJDA M. KLEIN</b>	<b>W. FISCHER C.G. HENNINGSEN</b>	<b>A. GUALANO</b>
<b>TenneT TSO B.V. Netherlands</b>	<b>Delft University of Technology Netherlands</b>	<b>Austrian Power Grid AG Austria</b>	<b>Wienenergie Stromnetz GmbH Austria</b>	<b>50 Hz Transmission GmbH Germany</b>	<b>Terna S.P.A. Italy</b>

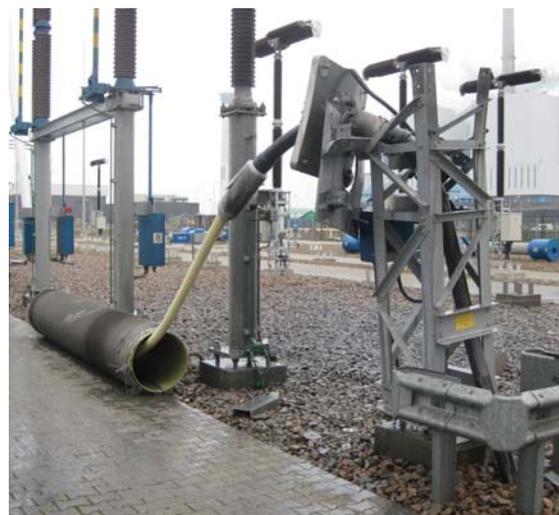
Figure 2: Failed 380 kV cable termination.

The impact of a cable system failure depends on the different TSO business values: Quality of supply, Environmental, Financial, Safety, Compliance, Customers and Reputation. Interruption of the power delivery has impact on the quality of supply. Moreover, an exploding termination will lead to safety issues, see figure 2. If the failing termination is oil filled, the oil will be spilled in the environment. Moreover, the explosion might damage other components close to the termination which will clearly lead to longer repair time and higher costs.

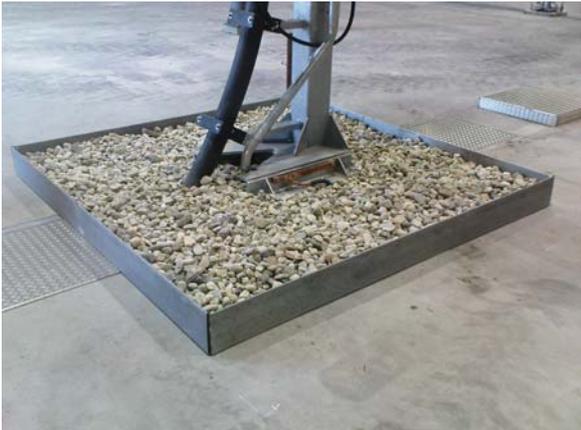
Figure 3: Grit-bed under a 380 kV cable termination to prevent spreading burning oil.

To prevent spreading of the burning oil leading to severe damage to other equipment, a grit-bed underneath a 380 kV cable termination can be applied, see figure 3.

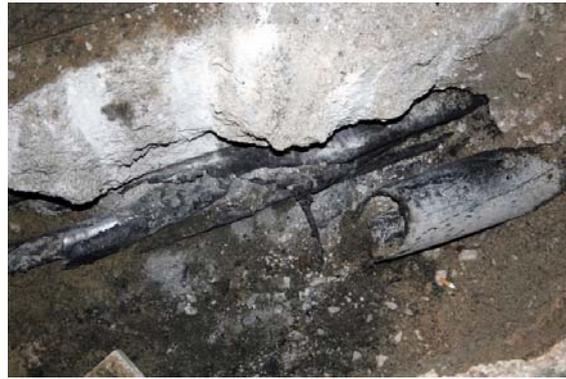
*Figure 5: thermal influence between two phases after a fault at a 110kV cable.*

Besides the different tests before installation, also between each installation step a sheath test should be carried out. This test indicates even small damages e.g. from handling. If such faults are undetected this can be the beginning of a major problem later on. For the design of the cable system the spacing of the phases is of major importance. Spacing can be done in trefoil as well as in flat formation. The advantage of backfilling the space between cable phases is the increased resistance against burning and heat influence, see figure 5.

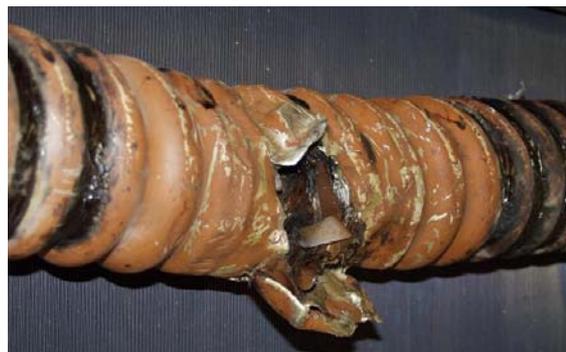
*Figure 6: damage at a 380kV cable from digging work.*

To prevent damage on cables as shown in figure 6, it is important to inform third parties before digging about the position of the cables. Normally if someone wants to dig, prior to this the owner of a property has to be asked for permission and for details about existing infrastructural facilities in the ground. If the property is under state or town ownership, the third party can be forced to respect and to take care of other important installations in a better way. It is therefore advisable to lay cables in public ground as much as possible.
