# Session 2024

## Key take away SC A1

**cigre**

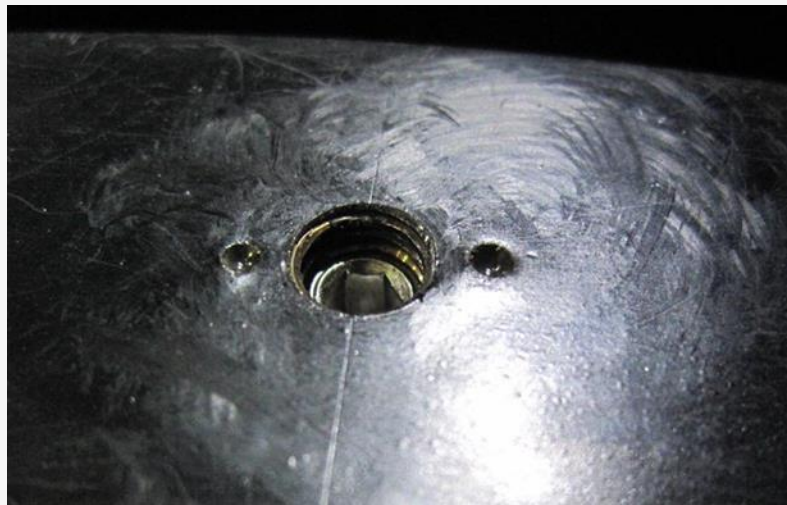
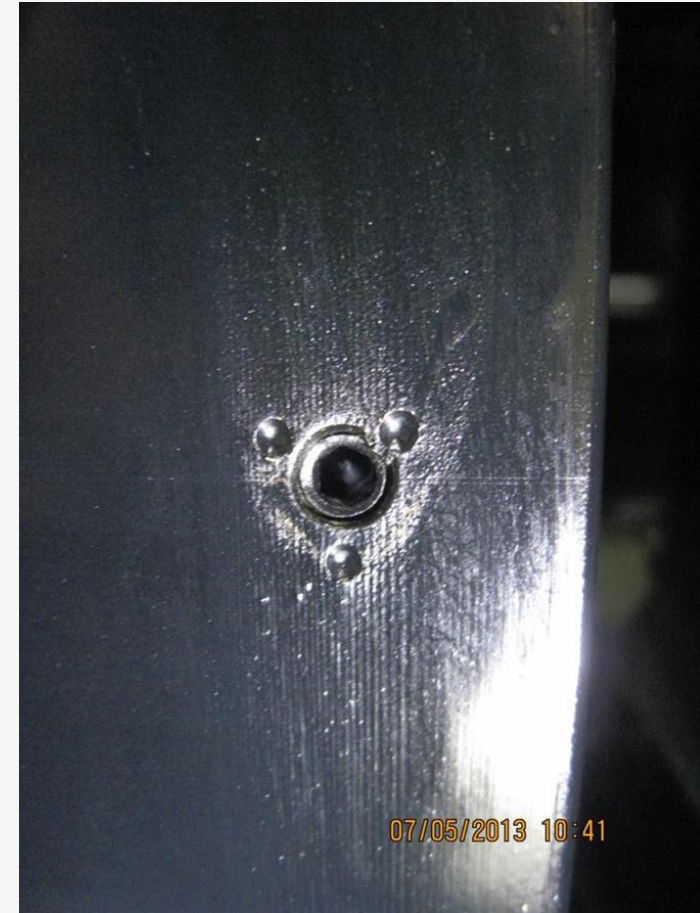
# Construction

- Aluminum short circuit ring (D = 1 m)
- Nickel aluminum bronze retaining ring (CuAl11FeNi4)
- Steel hexagon socket set screws (M8x25)
